Manhole Inspection Summary

Manhole # S21G1_015MH

Insp Date: **4/13/08 12:45 PM**

Location Address: **2712 hollins ferry rd**

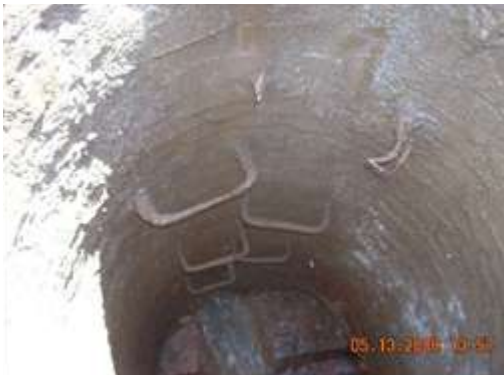
Defect 2

Count: **5** Missing: **1** ☒ **Corroded**

corroded & missing steps

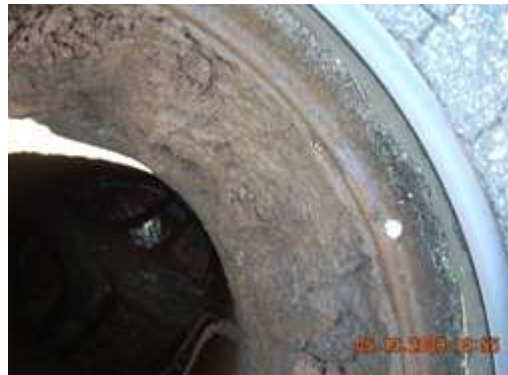
Defect 1

Offset: **2** (in.)

☒ **Leaks**

frame leaks, frame offset

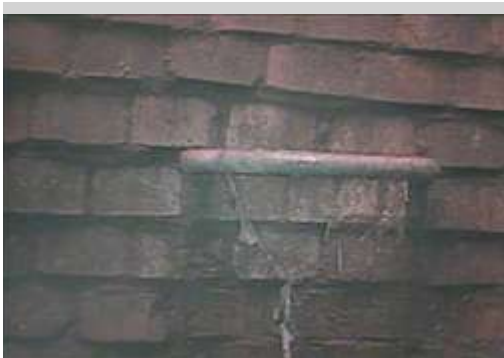
Defect 5

☒ **Evidence Of Surcharge** Depth: **3** (ft.) ☐ Active Surcharge Present

surcharge evidence

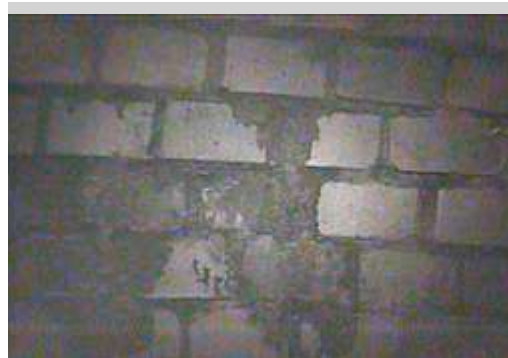
Defect 4

Infiltration: ☐ None ☐ Joint ☐ Cracks ☐ Mortar ☐ Roots ☒ **Wall**

infiltration @ barrel wall

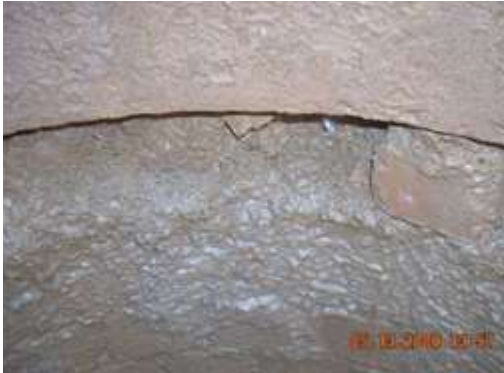
Defect 3

Condition: ☐ Sound ☐ Cracked ☐ Root Intrusion ☐ Loose Brick ☒ **Deteriorated**

Infiltration: ☐ None ☒ **Joint** ☐ Cracks ☐ Mortar ☐ Roots ☐ Wall

leaking @ joint and deteriorated chimney

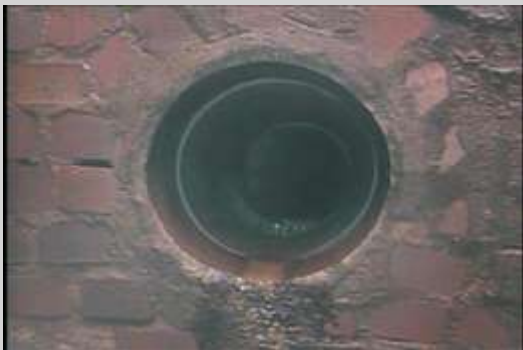
9 O'Clock Inflow

Infiltration: **Evidence** Pipe Seal Cond: **Sound**
